INDIVIDUAL PROPERTY/DISTRICT  
MARYLAND HISTORICAL TRUST  
INTERNAL NR-ELIGIBILITY REVIEW FORM

Property/District Name: George W. Hilton Farm Survey Number: M-13-18

George W. Hilton Farmhouse (13-18)  
Structural Analysis and Estimate of Costs

## INVENTORY FORM FOR STATE HISTORIC SITES SURVEY

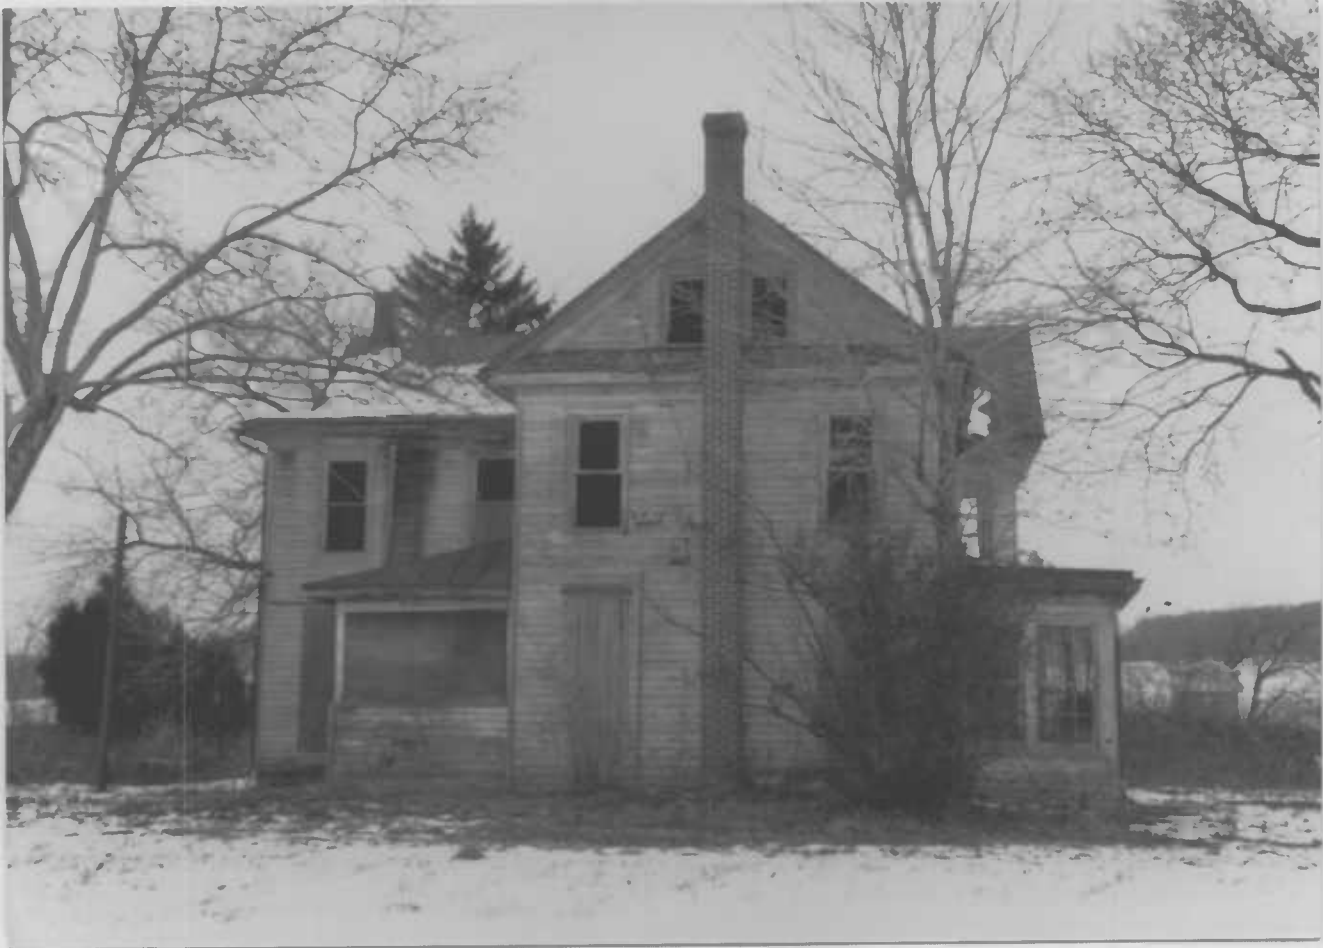
South Elevation

At the south elevation there is a 2½ story, two-bay, gable-roof wing extending to the rear from the southeast corner of the main block. The wing has an outside chimney with a corbelled cap, double windows at the gable end, and an entrance in the westernmost bay. There is a shingled overhang at the second story. A one-story, hipped-roof, enclosed porch partially fills in the ell where the main block and the wing meet, at the southwest corner of the house; entrance to the porch is on the west elevation.

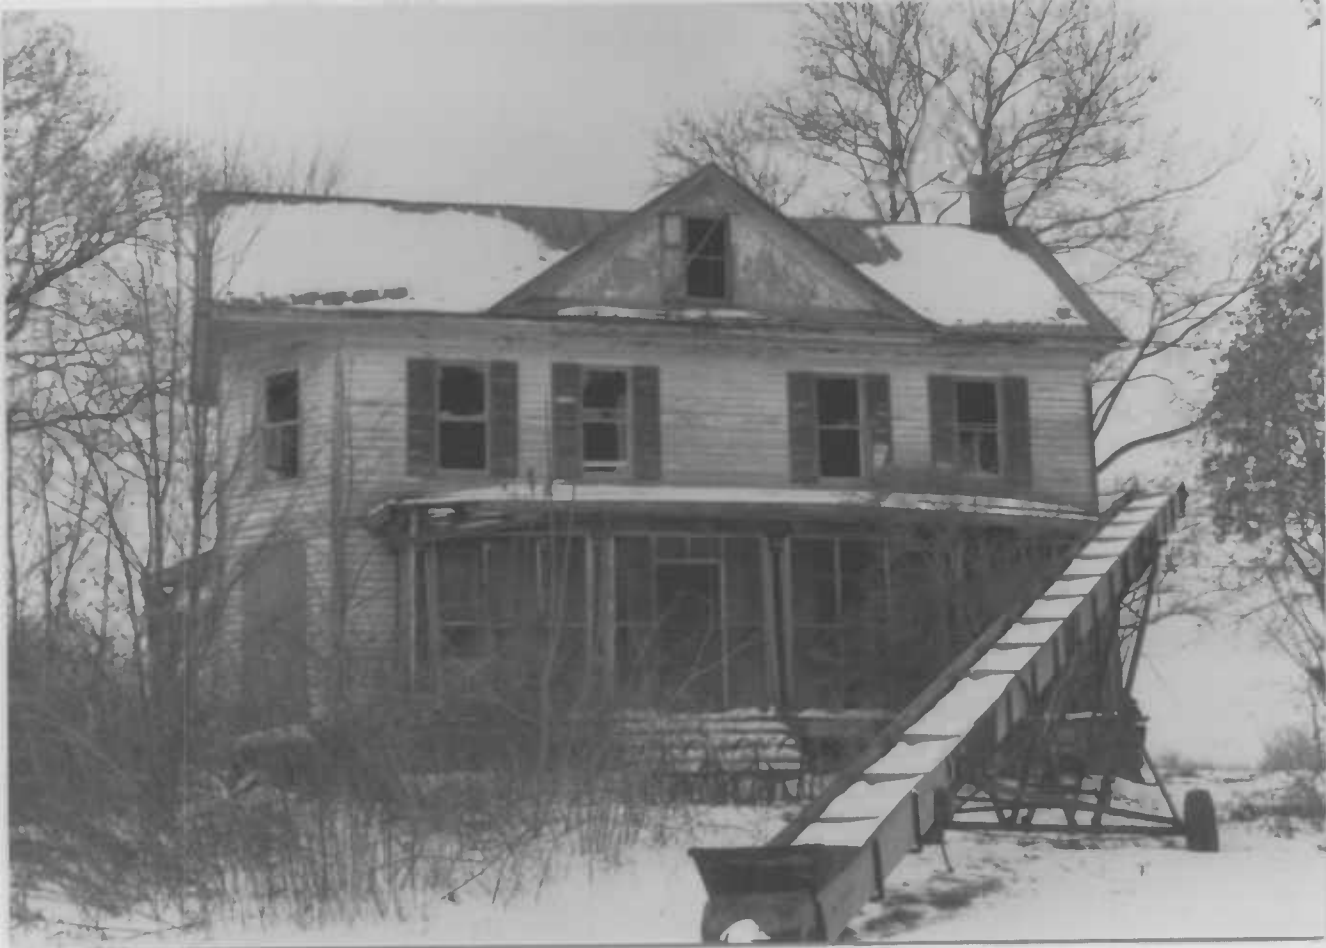
North Elevation

The symmetrical main block, which faces north, has a one-story, shed-roof screened porch which covers the full width of the facade; it rests on brick piers with latticework infill. Originally supported by classical columns, most of the columns are now missing. A centered second-story gable features a shuttered window and scalloped shingles, the same shingles decorate all gable ends. There is an interior chimney at the west end of the roof ridge.

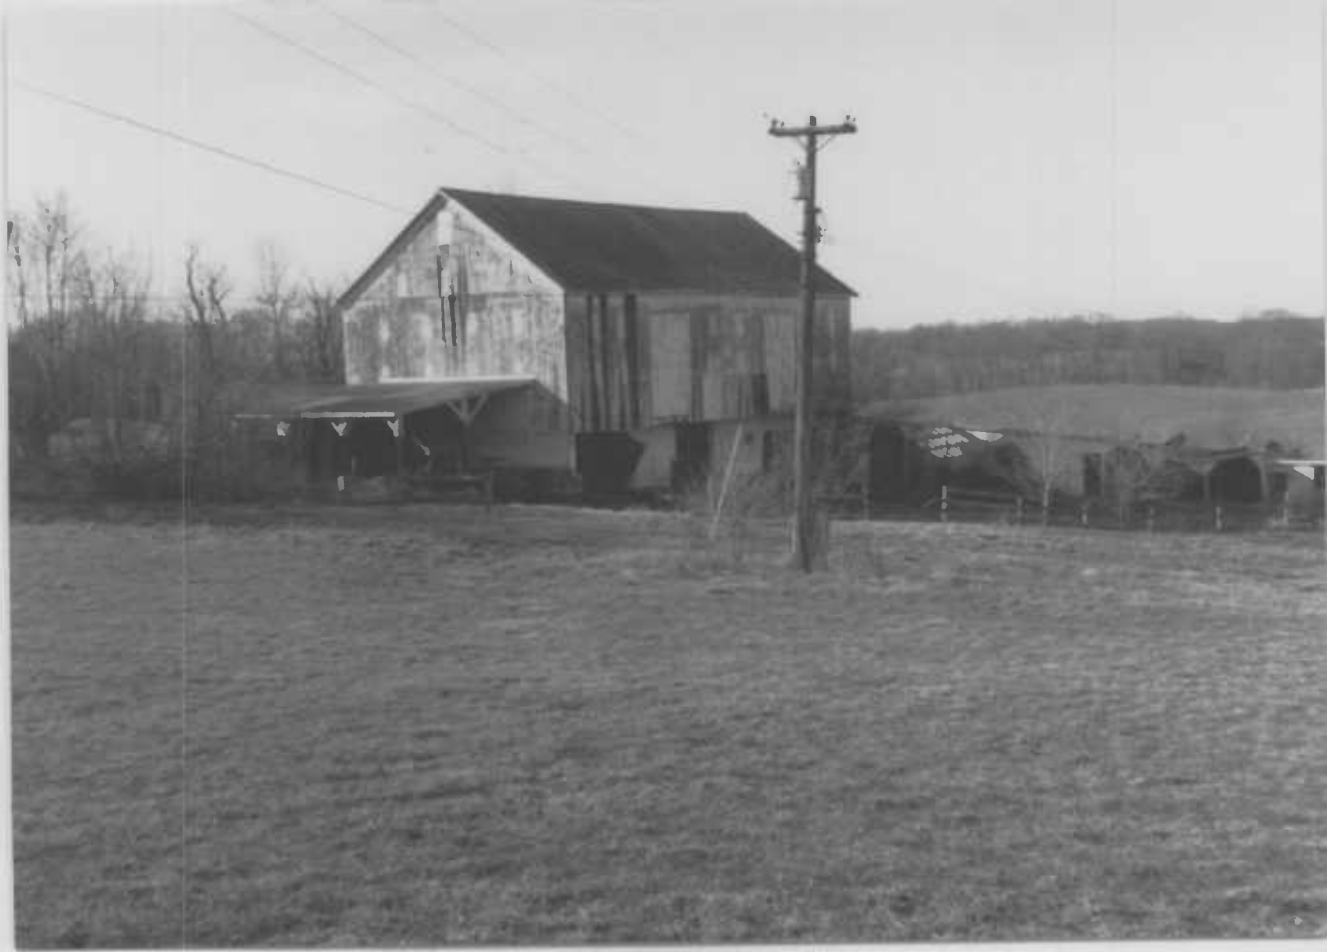
Outbuilding - East & North  
Bank Barn

There are a number of outbuildings on the site, the most important of which is an early twentieth century metal-roofed bank barn covered with vertical plank siding and resting on a stone foundation; its windows are outlined with paint and there are one-story additions at both gable ends.

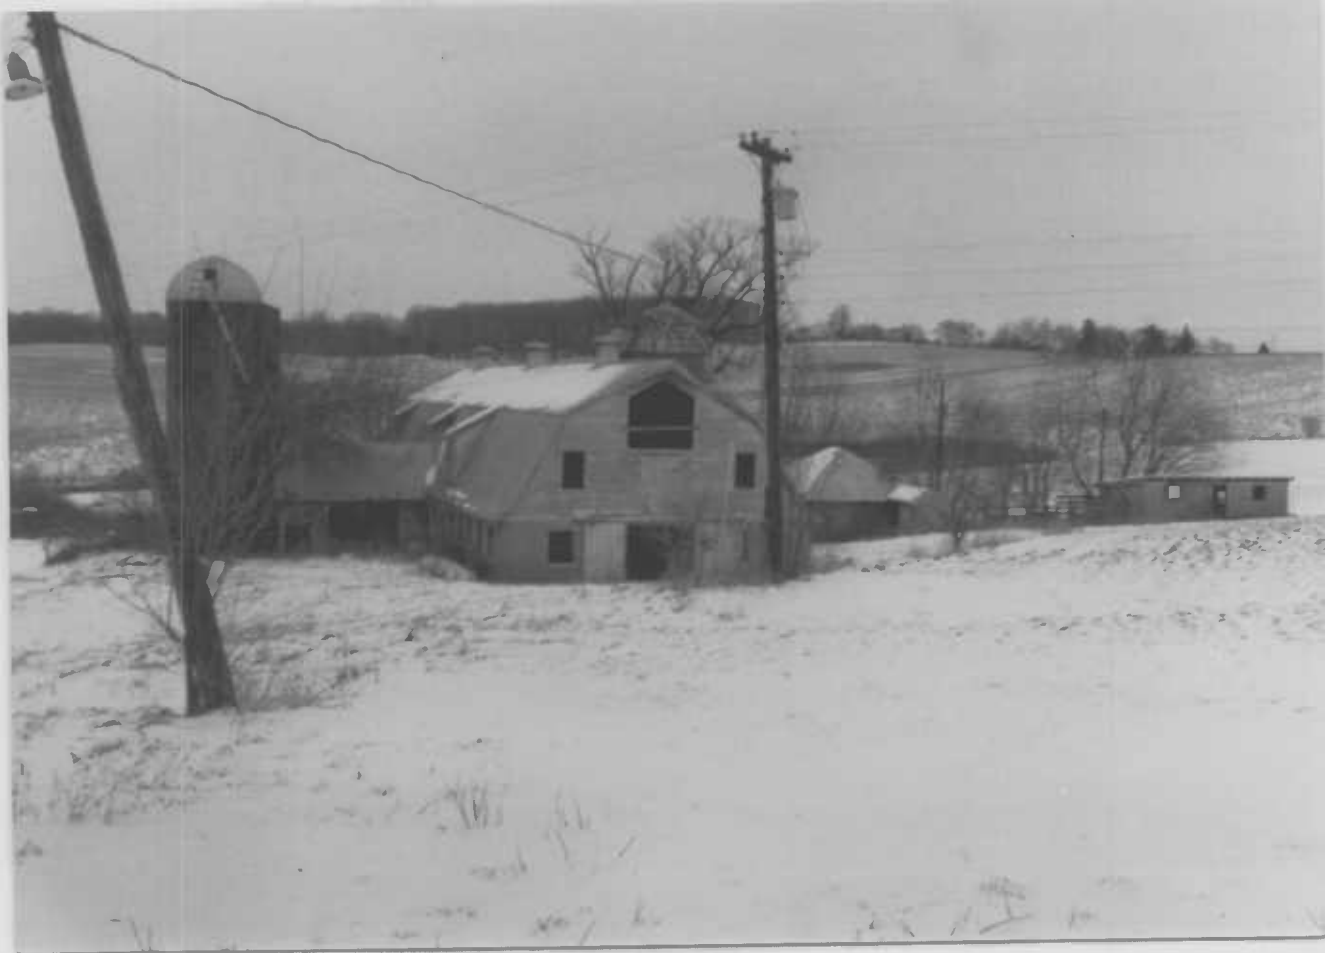
Outbuildings - Dairy Barn,  
Silos

The dairying complex on the Hilton farm includes the clapboard-and-concrete-block, metal-roof dairy barn (probably erected about 1923), a tile-covered, hipped-roof equipment building, and twin tile-covered silos, one of which has dormer windows at its peak.

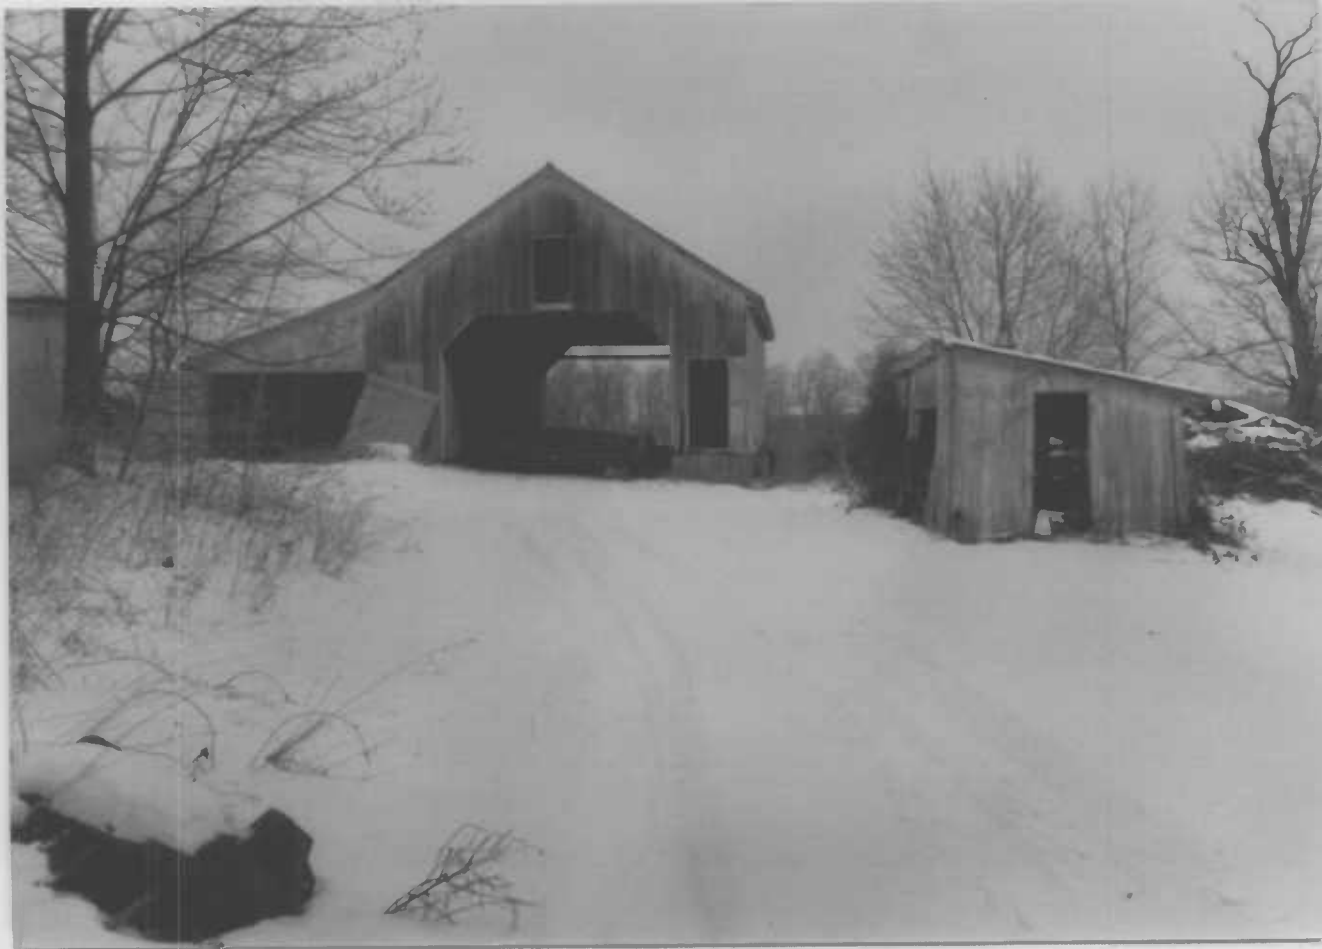
Outbuildings (East) Corn Crib,  
Machine Storage  
Shed

Other outbuildings date from the early-mid twentieth century and include a double corn crib and machine storage shed with cat-slide roof, also covered with vertical plank siding; a shed-roof, vertical-sided hen house; and a number of smaller outbuildings (built with vertical plank siding or concrete block, with shed or gable roofs) used for equipment storage or livestock.
